Application Brief

# Automated Radiographic Testing (ART) Inspection Services

## Advanced Piping/Pipeline Corrosion Inspection Technology

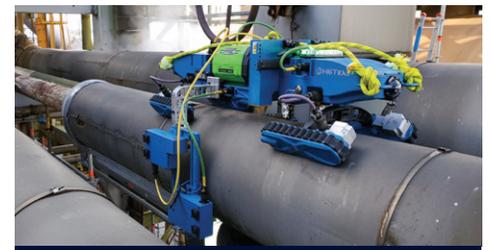
Scanning a full pipeline diameter using the multi-view approach of the 2-axis arm

MISTRAS' patented technology has the unique ability to inspect 100% of a pipe in the time it typically takes to inspect 10% using manual methods\*. Our ART services can also inspect in-service piping with product still flowing through them. Our proprietary design is fully wireless and offers single view or multi-view radiographic scan, simultaneously analyzing the top, bottom, and sides of piping with a 2-axis robotic arm to autonomously drive over supports without the need for multiple set-ups or systems.

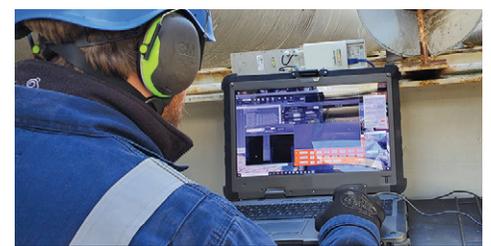
MISTRAS' ART services provide DICONDE-compliant results in real time

The crawlers' self-leveling motion control system and built in fall arrest technology ensure safe rope access use and the elimination of costly scaffolding. By giving pipeline operators the opportunity to review inspection video and DICONDE compliant radiographic results simultaneously, they can collect, process, and analyze data much faster. Collected images are then digitally stored, providing a long-term, easily traceable, and readily-available record of damage.

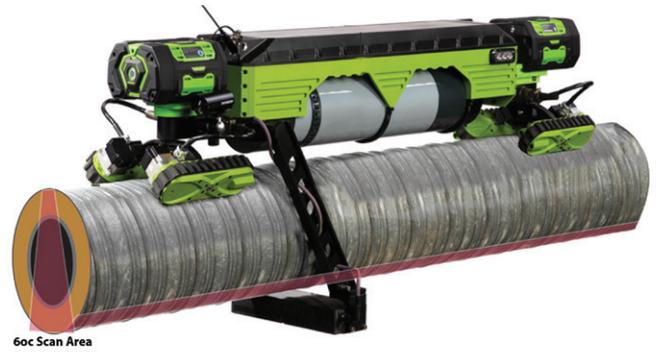
6oc Scan Area

INTERNAL CORROSION CRAWLER SERVICES	
VIEWS	1
PIPE RANGE (INSULATED)	4" - 48"
ENERGY	225 kV
COMMUNICATION	Wireless
MARKET	Up, Mid, Downstream
WEIGHT	70 lbs.
CLEARANCE	<b>Robotic Arm:</b> Top- 10"; Bottom- 2"; Side 1- 4"; Side 2- 0"; <b>Stationary Arm:</b> Top- 10"; Bottom- 2"; Side 1- 2"; Side 2- 0"
DIMENSIONS	54.5" x 7" x 9.75"
EXPOSURE TECHNIQUE	Double Wall Single View (ID+OD)
TEMPERATURE RANGE	-40°F to 120°F
POWER REQUIREMENTS	56V Lithium Ion Battery
APPROVAL	CE
AVAILABILITY

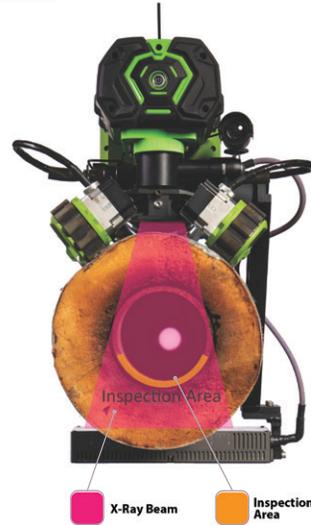
4-VIEW CUI CRAWLER SERVICES	
VIEWS	4 (Bottom, Top, Both Sides)
PIPE RANGE (INSULATED)	2" - 20"
ENERGY	70 kV
COMMUNICATION	Wireless
MARKET	Up, Mid, Downstream
WEIGHT	37 lbs.
CLEARANCE	<b>Robotic Arm:</b> Top- 8"; Bottom- 2"; Side 1- 4"; Side 2- 3.5"; <b>Stationary Arm:</b> Top- 8"; Bottom- 2"; Side 1- 2"; Side 2- 3.5"
DIMENSIONS	36" x 6" x 8"
EXPOSURE TECHNIQUE	Tangential (OD Only)
TEMPERATURE RANGE	-40°F to 120°F
POWER REQUIREMENTS	56V Lithium Ion Battery
APPROVAL	CE
AVAILABILITY
