eGuide

How to Detect Corrosion Under Insulation (CUI) in Your In-Service Piping & Pipelines

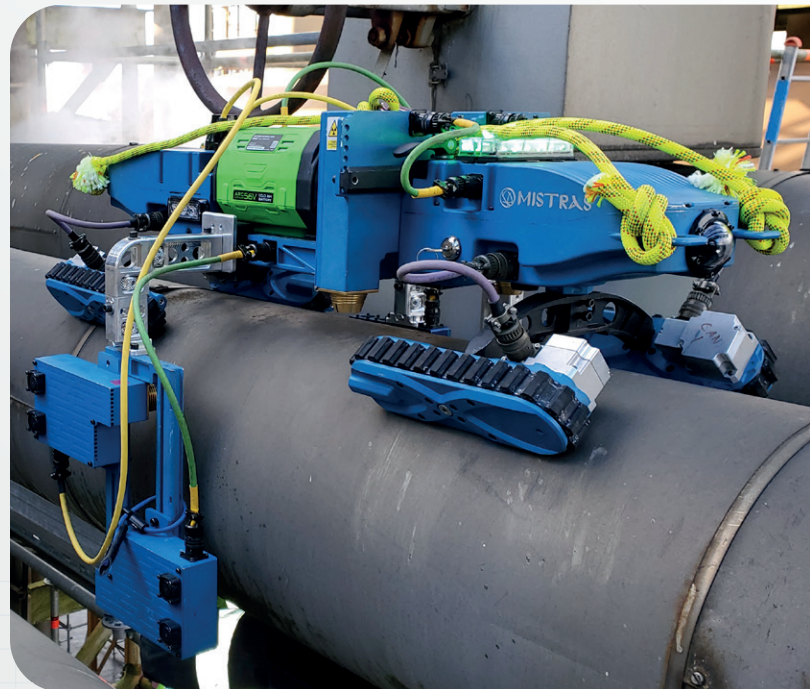
ART Crawler: A Non-Invasive CUI Inspection Innovation

MISTRAS' ART Crawler is an advanced inspection service that utilizes digital radiography (DR) to screen for internal corrosion and corrosion under insulation (CUI) in insulated and uninsulated aboveground piping and pipelines, even with product flowing through the lines. The ART Crawler utilizes modern robotic technology to accurately detect damage locations quicker than traditional techniques and with no need to remove insulation or take the pipe out of service.

Designed, developed, and manufactured in-house by MISTRAS Group, the ART Crawler has various iterations each designed to detect different damage mechanisms in piping and pipelines in the upstream, midstream, and downstream sectors of the oil & gas industry. ART Crawlers designed to detect CUI are applicable for pipes ranging from 2"-20" in diameter, while the systems designed to detect internal corrosion are used in piping 4"-48" in diameter.

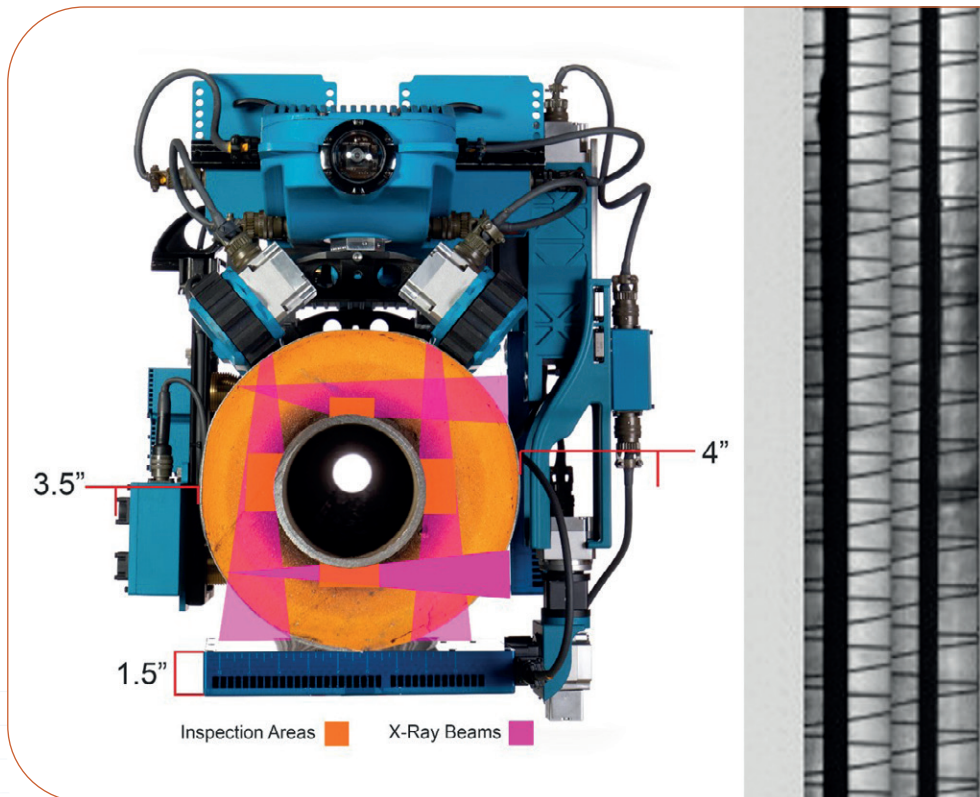
Automated Radiographic Testing (ART) Explained

The ART Crawler produces digital images during pipeline inspections and offers the ability for operators to review inspection video and DICONDE-compliant radiographic results simultaneously for faster data collection, processing, and analysis.

When inspecting for CUI, MISTRAS' ART Crawler services utilize a tangential radiography technique. It can inspect all four axes of a pipe simultaneously with 4 low-powered X-ray tubes that shoot tangentially across the pipe to produce silhouettes of the pipe wall. Two state-of-the-art, high-sensitivity X-ray detectors on the opposite sides of the pipe acquire the images, which are then displayed in real-time on the laptop used by the technician operating the crawler.

A certified MISTRAS technician can mark areas of concern as the system scans, and the crew can quickly move the crawler between runs by detaching the modular arms and reassembling the crawler on the new run. The X-ray images and video from the onboard cameras can be sent immediately to the customer for critical decisions, and the crawler's 100% scanning coverage allows piping to be audited year after year.
